Klickitat Watershed Enhancement Project

Annual Report for January 1, 2009 – December 31, 2009

BPA Project # 1997-056-00

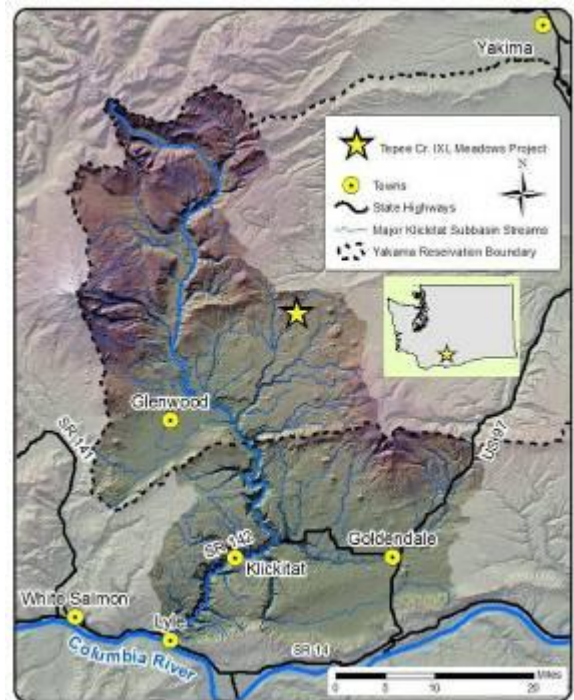
Figure 6. Map of Tepee Creek Meadows Restoration – Phase 2.

Site and Watershed Description: The project reach consists of approximately 1 mile of Tepee Creek in the vicinity of river-mile 5 (Fig. 6) and immediately downstream of the IXL Meadows Restoration Project (completed 2007; Conley 2008). The site is at 2900' elevation. The reach is a mix of meadow, ponderosa pine parkland and mixed conifer forest. The contributing drainage area is 8.4 square-miles
