Klickitat Watershed Enhancement Project (KWEP)

Yakima/Klickitat Fisheries Project (YKFP)

Report for January 1, 2012 - December 31, 2013

BPA Project # 1997-056-00

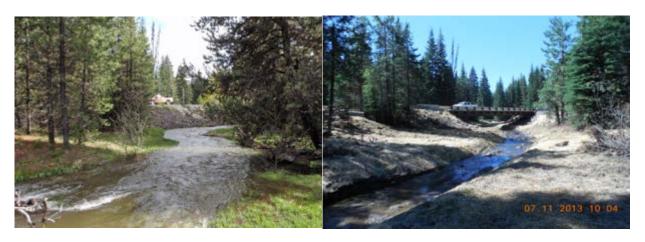
Figure 3. Upper Klickitat River In-channel and Floodplain Enhancement – Phase 3 pre (left) and post bridge installation (right) looking in the downstream direction above the 255 rd-xing.

Project Outcomes: The primary outcome of the project was the replacement of an undersized culvert (18" CMP with obstructed inlet and outlet) with an 80' x 24' steel bridge (Figs. 3 and 4). As a result

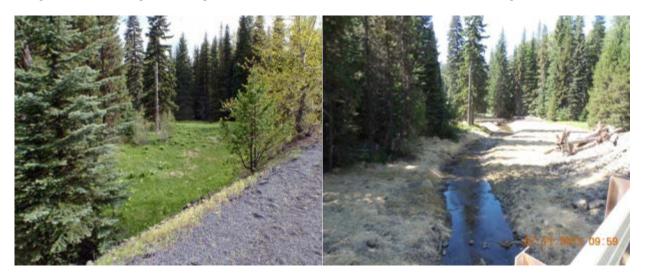
Figure 4. Upper Klickitat River In-channel and Floodplain Enhancement – Phase 3 pre (left) and post bridge installation (right) looking in the downstream direction below the 255 rd-xing.

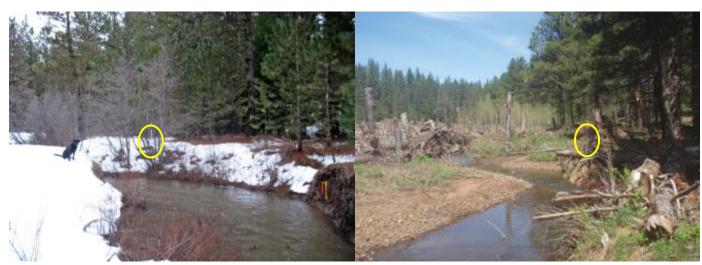
Figure 8. Tepee Creek Meadows Restoration – Phase 2 pre (left) and post riffle construction (right) and LWD placement, well (yellow circle) placement is consistent in both pictures although "post" picture is taken with a wider angle.

- LWD was placed for transitions between the imported gravel and existing valley bottom surfaces. LWD was designed to encourage local scour to maintain pool depths and volumes, control lateral erosion, and provide primary habitat (Fig. 8).
- A roughened channel, on a steepened grade (approximately 3%) is designed to provide downstream control for the reach and transition between restored bed elevations and the somewhat incised channel downstream.
- Constructed riffles consist of imported gravel that are immobile at <Q_{1.3} and has sufficient fine content to control porosity (Fig. 9).
- Floodplain roughness elements (LWD) were placed to prevent avulsion around edges of the imported material or across smooth floodplain surfaces.

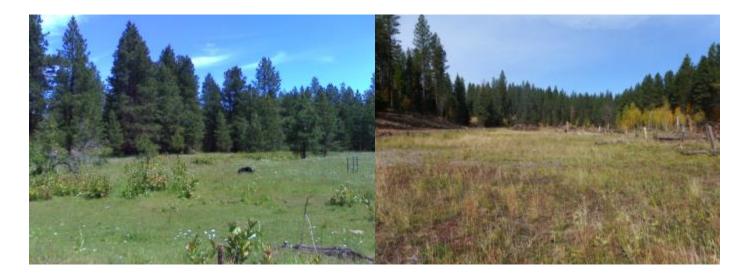
Figure 10. Tepee Creek Meadows Restoration – Phase 2 pre (left) and post (right) reduction in conifer encroachment. Pictures depict meadow conditions before and after the treatment.

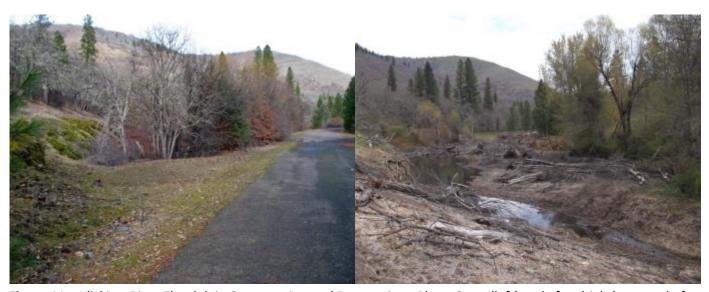
Figure 11. Klickitat River Floodplain Conservation and Restoration—Phase 3 pre (left) and after (right) removal of road prism, construction of channel and grading of floodplain.

- Approximately 8,900 l.f. of embankment graded to enhance riverine and floodplain function:
- ~1780' of floodplain channel constructed
- Placement of 45 pieces of wood placed to create floodplain roughness
- Restored deformability of channel margins to permit lateral channel migration and serve as long-term LWD source
- Restored hillslope interaction
- Removed asphalt from 1.7 miles of floodplain road
- Removed 6 cross drain culverts, 3 culverts from non-fish bearing tributary, and 1 culvert from a seasonal fish-bearing tributary

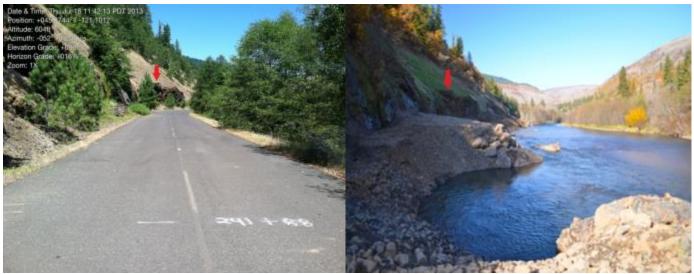
Figure 12. Klickitat River Floodplain Conservation and Restoration—Phase 4 pre (left) and after (right) removal of road prism and exposure of bedrock outcrop.

- Approximately 8,300 l.f. of asphalt removed
- 4,435 l.f. of fill removed
- 3,854 l.f. of fill pullback
- embankment graded to enhance riverine and floodplain function:
 - Restore deformability of channel margins to permit lateral channel migration and serve as long-term LWD source
 - Restore hillslope interaction
- Access to 9.78 acres of floodplain habitat restored
- Removed 3 culverts and restored access a to 1 seasonal fish-bearing tributary

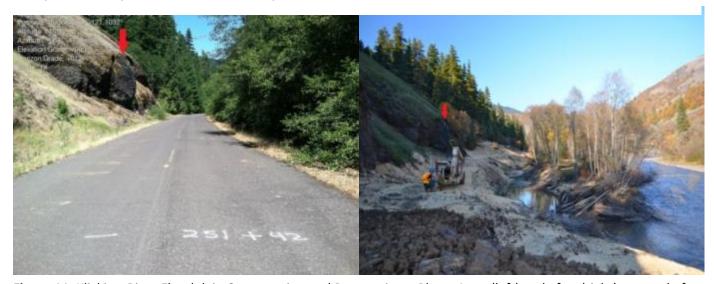
Figure 11. Klickitat River Floodplain Conservation and Restoration – Phase 4 pre (left) and after (right) removal of road prism, construction of channel and grading of floodplain.

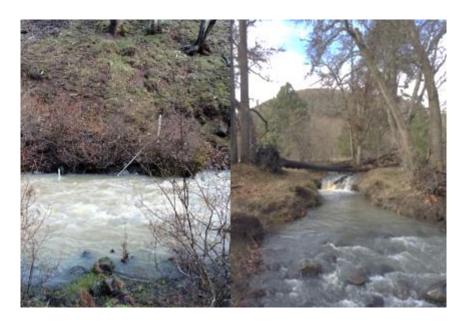
Figure 13. New streamflow gaging stations installed in 2012, Wheeler Creek (left) and Logging Camp Creek(right).

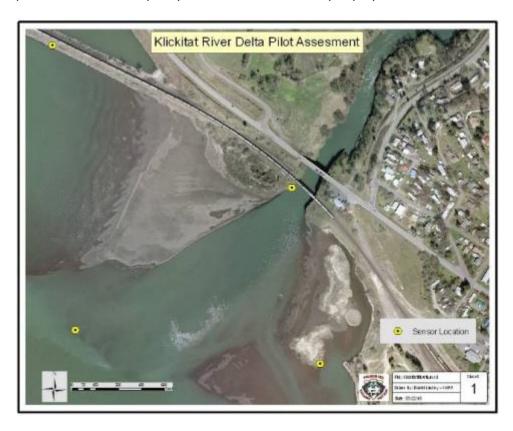
Figure 17. Sampling locations for the Klickitat River delta.

During the reporting period the sensor array installed in August of 2009 was operated continuously (Fig. 19). Primarily data collection was monitored via an ftp site KWEP staff can access from the Klickitat Field Office. KWEP staff from time to time observed discrepancies, errors, data gaps, or non-reporting dictated site visits for troubleshooting purposes. Additional site visits were conducted to collect staff gage observations during a range of stages (Fig. 20) to establish stage reference points. These reference points are utilized to quality control data collected by deployed sensors.

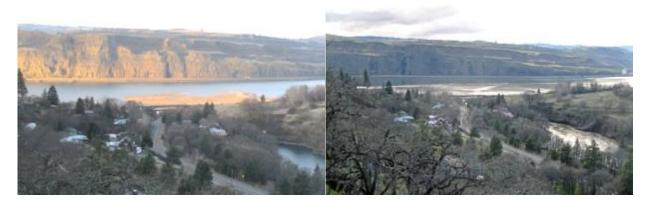
Figure 18. Klickitat River delta at low (left) and high Bonneville Pool and Klickitat River stage (right). Photos of stage levels were taken on February 20, 2012 and March 31, 2012 respectively.

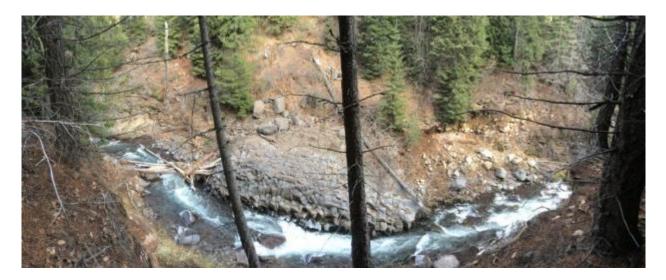
Figure 191. Panoramic picture of Big Muddy Creek depicting canyon nature of site and challenges inherent in gaging operation.

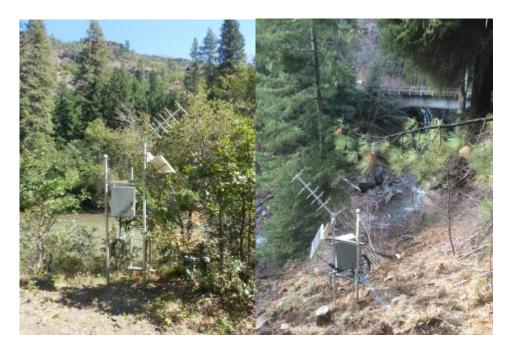
Figure 20. Telemetry communication equipment, Klickitat River DS of Summit Ck (upper left) and Big Muddy Ck @ 255 rd x-ing (upper right).

KWEP staff installed telemetry equipment at two existing sites to facilitate remote data transmission (Big Muddy Ck @ 255 rd x-ing and Klickitat River ds of Summit Ck). Due to the remoteness of the sites and critical nature of having functioning equipment during these episodes of increase turbidity, communication via the GOES satellite network was established (Fig. 21). The hardware and software were purchased through YSI Incorporated. Programming of sensors, communication, and hardware installation was performed by KWEP staff (Fig. 22). Data are accessed via the Web multiple times a week to ensure the station is functioning properly.
