Klickitat Fishway

Project

One Down,

One to Go!

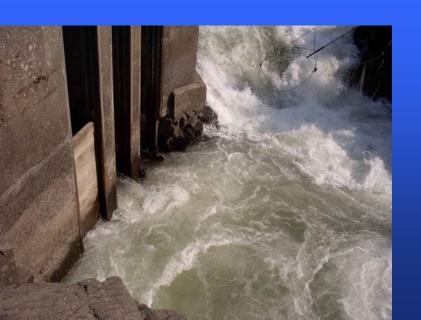
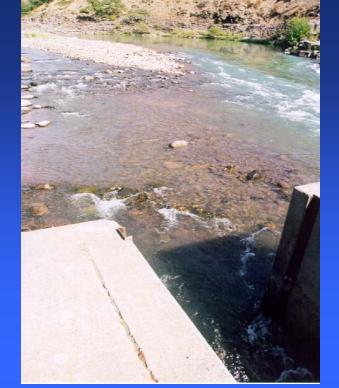
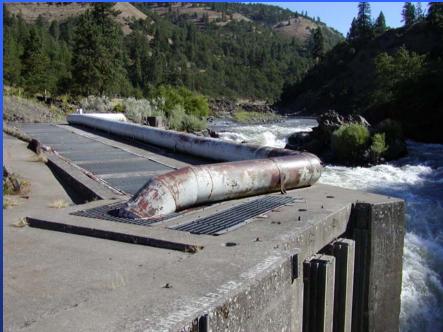
Lyle Falls Fishway - Current Condition

- Poorly Positioned Fishway Entrance
- Inadequate Attraction Water Supply
- Over-energized Resting Pools
- Inadequate Low Flow Water Supply
- •Gravel-impacted Fishway Exit Channel
