# Fox Creek Habitat Restoration: Restoring Function on Century- Old Working Lands

Joe Lemanski  
Confederated Tribes of Warm Springs Reservation of Oregon  
John Day Basin Habitat Restoration Monitoring Coordinator  
Gorge Sciences Conference  
April 16<sup>th</sup>, 2019

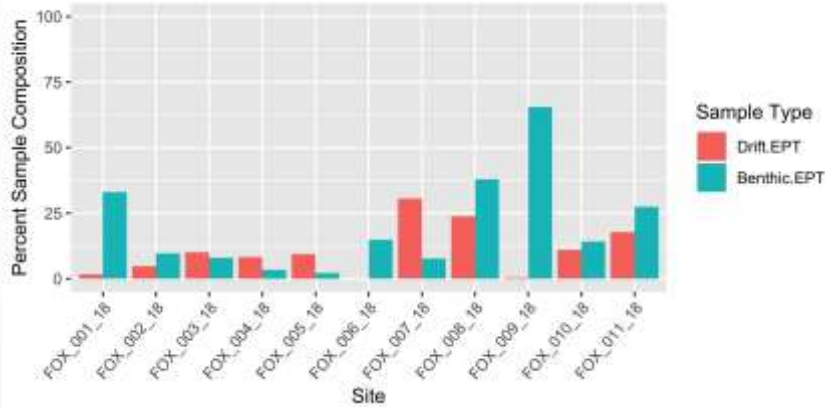
Summer EPT Composition for Drift and Benthic Samples

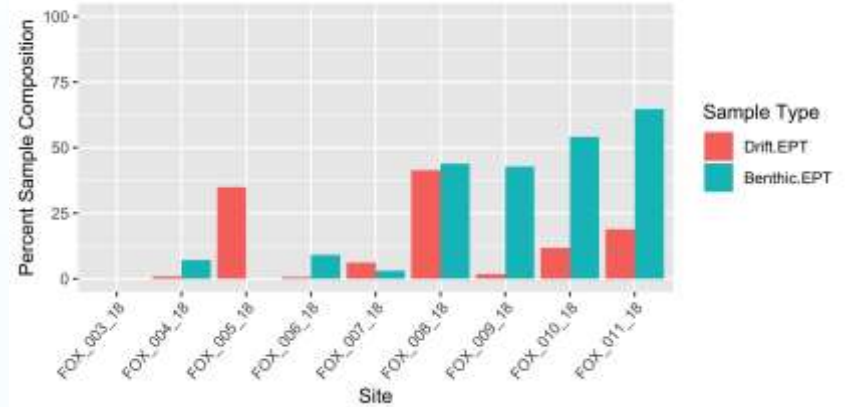
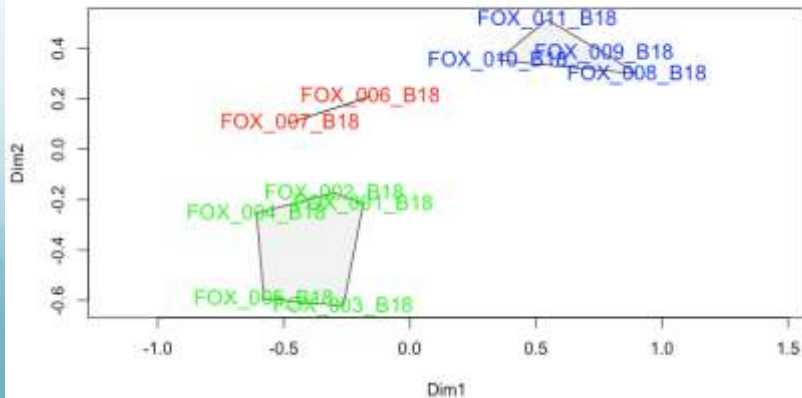
Fall EPT Composition for Drift and Benthic Samples

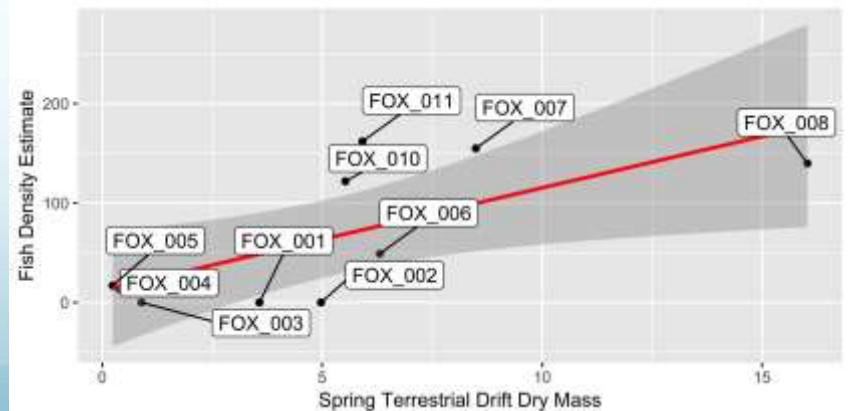
Adj R2 = 0.41906 Intercept = 11.694 Slope = 10.363 P = 0.025561

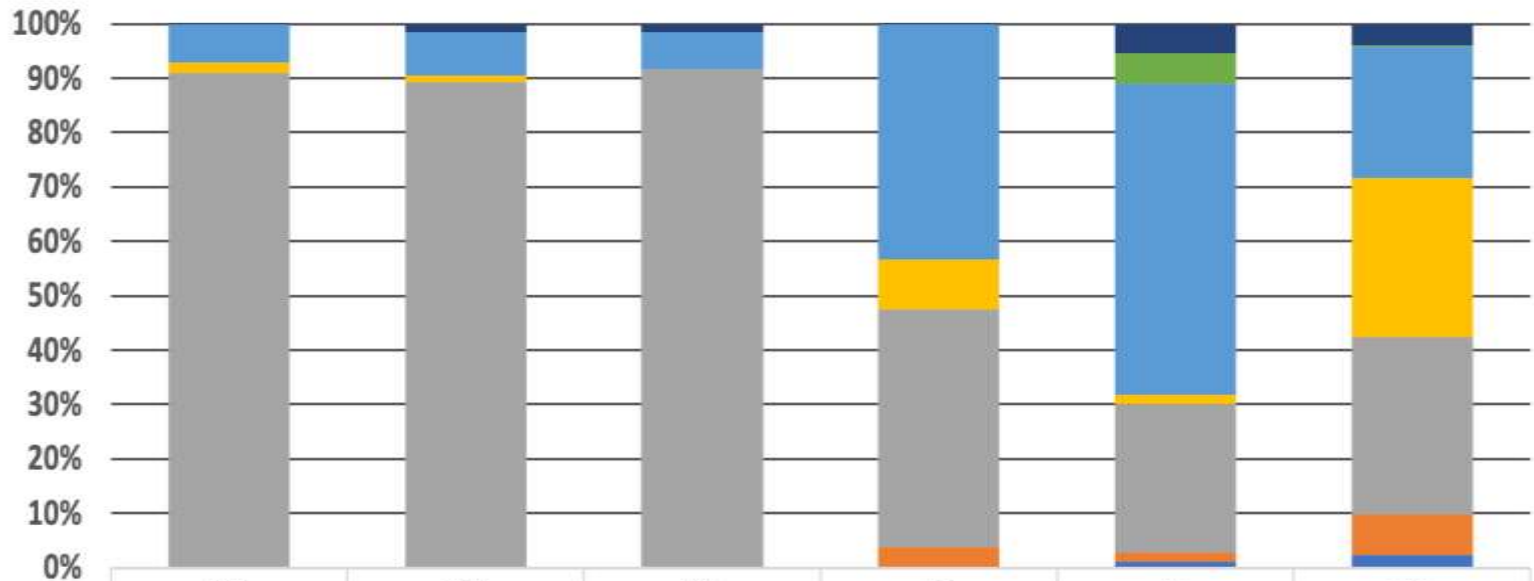
Fox Creek Riparian Vegetation Structural Composition

T1	T2	T3	T4	T5	T6
■ Bare Soil	0.1	1.5	1.6	0.1	5.3	3.9
■ Rock	0	0.1	0	0	5.6	0.1
■ Duff	6.9	7.9	6.8	30.2	57.3	23.6
■ Sedges	2	1.2	0	6.5	1.7	28.3
■ Grasses/Forbes	91	89.3	91.6	30.6	27.3	31.7
■ Shrub	0	0	0	2.6	1.5	7.1
■ Canopy Closure	0	0	0	0	1.2	2.3

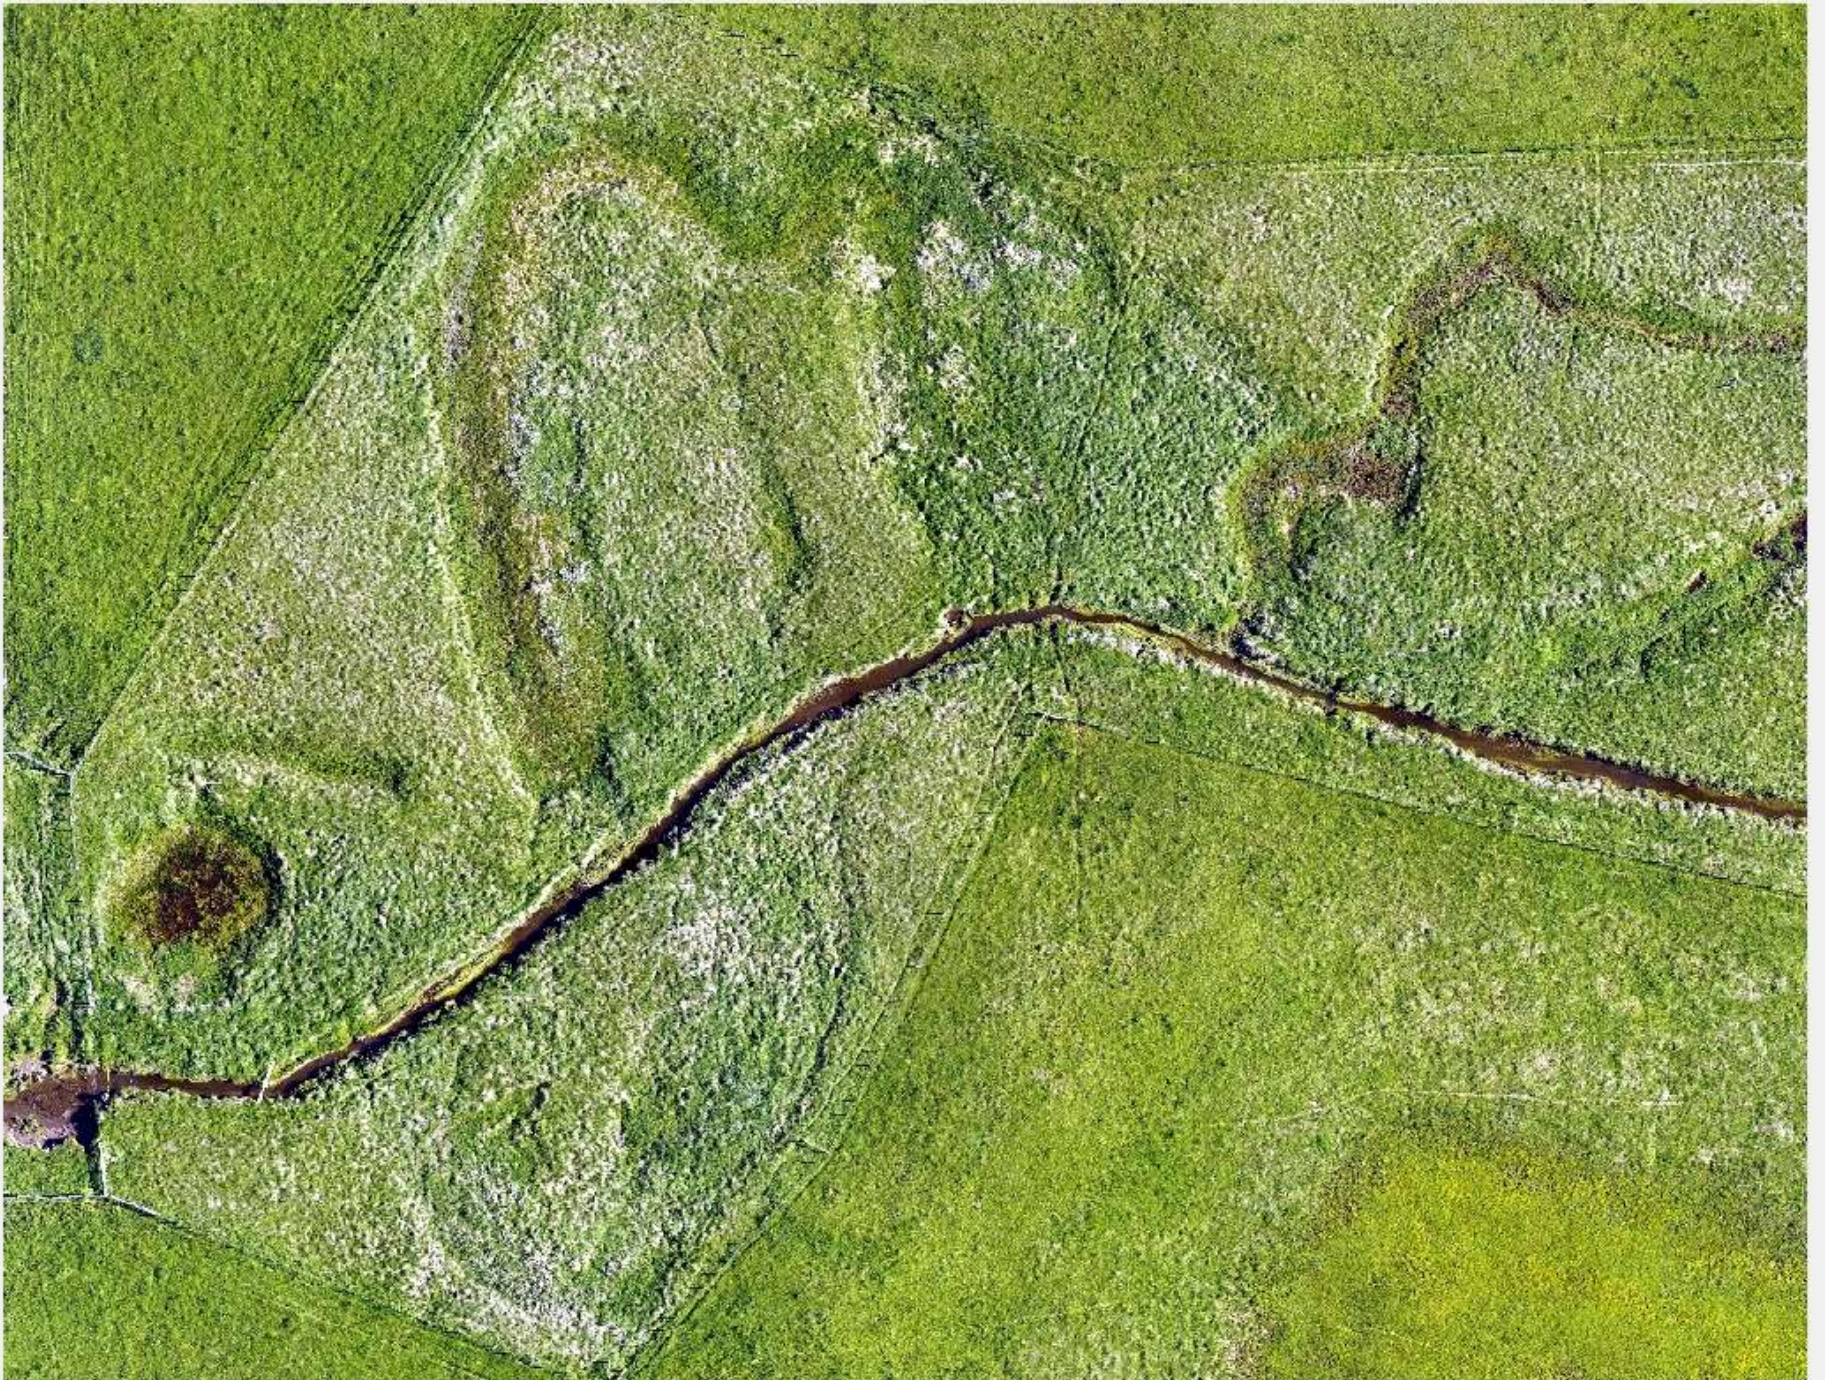
ALIGNMENT

LWD#4  
SEE NOTE 4.

LWD#315  
SEE NOTE 2.

LWD#5  
SEE NOTE 5.

LWD#336  
SEE NOTE 3.

LWD#7  
SEE NOTE 4.

LWD#3  
SEE NOTE 4.

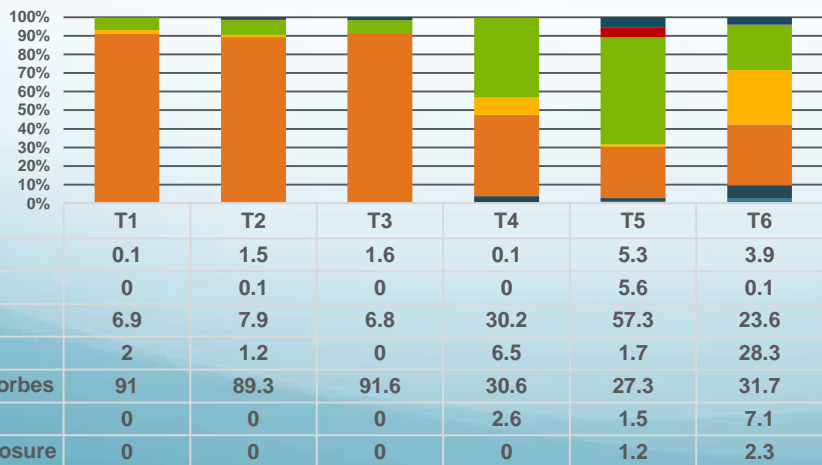
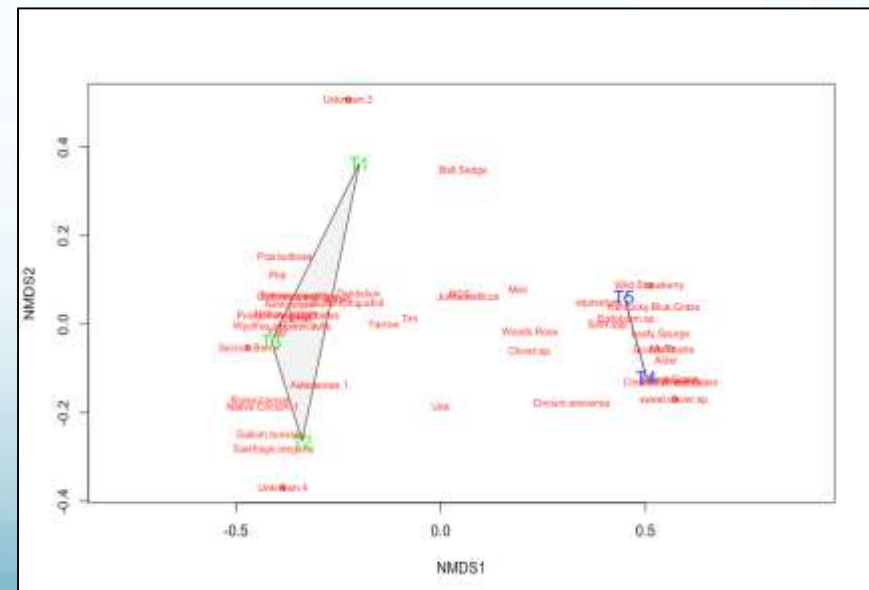
Fox Creek Riparian Vegetation Structural Composition

- Rapid Riparian Index of Biotic Integrity (R<sup>2</sup>IBI)
  - Quickly quantify riparian metrics
  - Measure change through time
  - Trend and Status
  - Employable by non-specialists (i.e. fish biologists)
